Interior crack initiation during the very-high-cycle fatigue of railway wheel steel under axial loading and rolling contact loading

Xiao-Long Liu¹, Pengcheng Gao¹, Si Wu², Guanzhen Zhang², and Tao Cong²

²China Academy of Railway Sciences Corporation Limited

November 30, 2021

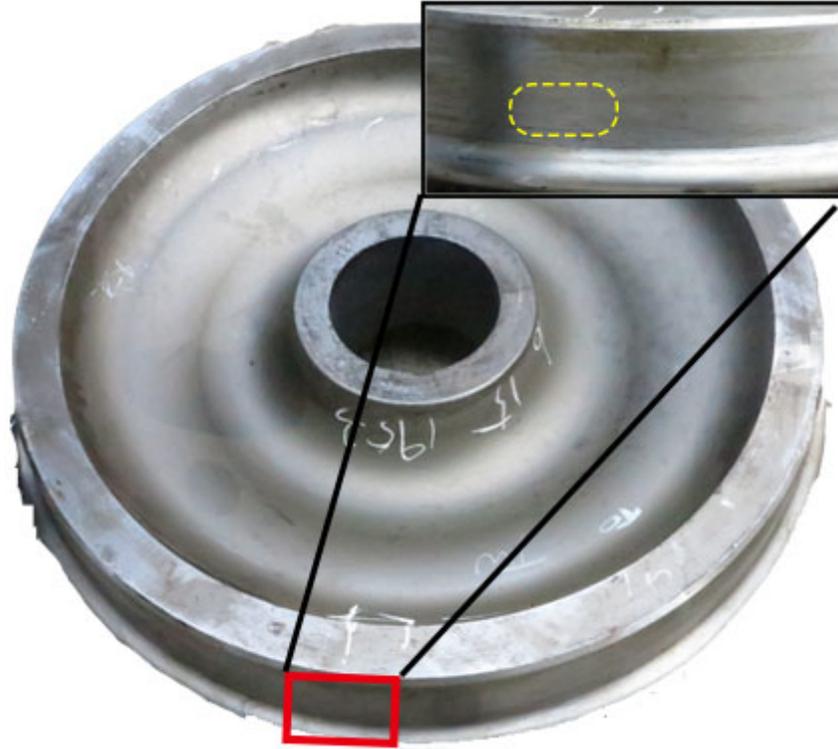
Fig. 2. Photographs taken from railway wheels with nonpenetrating shattered rims.

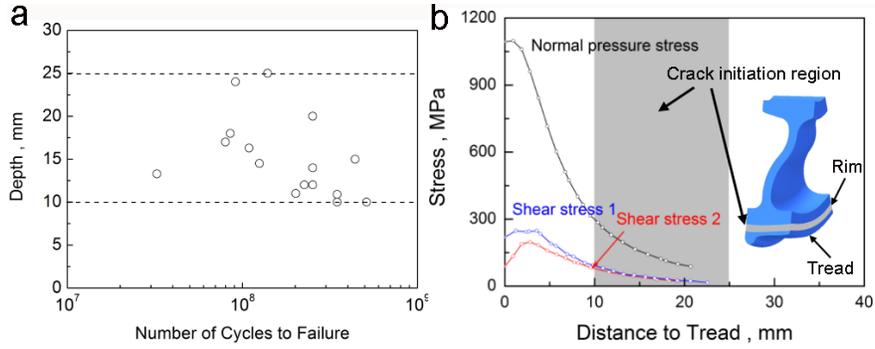
Fig. 4a shows the depth of the crack initiation region from the tread versus the fatigue life for shattered rims from the statistical data over the last ten years. The fatigue life was independent of the depth of the crack initiation region. The depth of the crack initiation region from the tread was in the range from 10-25 mm for all the shattered rims. The wheels with shattered rims had a service from 10^5 - 10^7 km, and the corresponding fatigue life was within a range from 10^7 - 10^9 cycles, which indicates VHCF behavior. The stress distribution for the VHCF under axial loading can be regarded as uniformly distributed axial stress. The stress distribution for the VHCF under rolling contact loading is a multiaxial stress consists of a pressure stress in the radial direction, a shear stress in axle direction and a shear stress in circumference direction. complicated. Fig. 4b presents the stress variation along the radial direction of the wheel. For the case of shattered rim (interior crack initiation) with the depth 10~25 mm, the pressure stress is in the elastic stage, and no evident press between the crack surface was observed. Meanwhile, the two shear stresses are also in the low level. It is consistent with VHCF features of a relatively low cyclic stress below conventional fatigue limit and beyond 10^7 fatigue cycles.

Fig. 4. (a) Depth of crack initiation region versus fatigue life for wheels in service, (b) stress distribution along the direction of wheel diameter, inset showing the crack initiation region in the wheel rim.

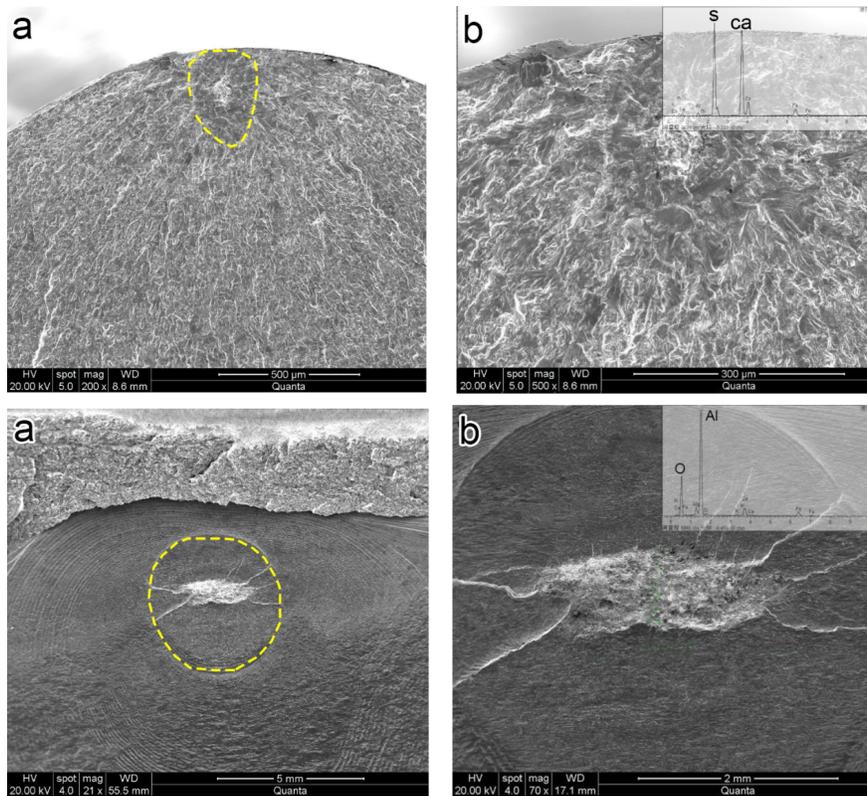
Fig. 6a presents the fracture surface of shattered rims under rolling contact loading, indicating three typical regions with different morphologies, i.e., the inclusion (Al_2O_3 by EDS in Fig. 6b), FiE, and crack propagation regions with fatigue bands. The uniform equidistant distribution of fatigue bands in the propagation region is a unique feature of the VHCF under rolling contact loads, which indicated that the crack propagation rate was constant, as marked by the arrows in Fig. 6a. This feature differed from the rapid propagation for the case of uniaxial loading. Although FGAs were typical features in the crack initiation region for VHCF under uniaxial loading [17], FGAs were not observed around the inclusions for the case of rolling contact loading. For the shattered rims, a rolling contact loading was applied to the wheels, which is a multiaxial stress state as shown in Fig. 4b. Due to the large compressive stress on the contact surface that normally suppress any Mode I deformation of the crack, the crack propagated mainly in a mixed Mode II- III [6]. Therefore, the fracture surface of the shattered rim was the typical morphology for VHCF with a mixed Mode II- III crack.

Fig. 6. Fracture surface of shattered rims under rolling contact loading, where $N_f = 3.38 \times 10^8$: (a) SEM image showing three regions of the inclusion, FiE, and crack propagation region with beach marks, and (b) high-magnification SEM image showing the FiE region, where the inset shows the EDS results of the inclusion.

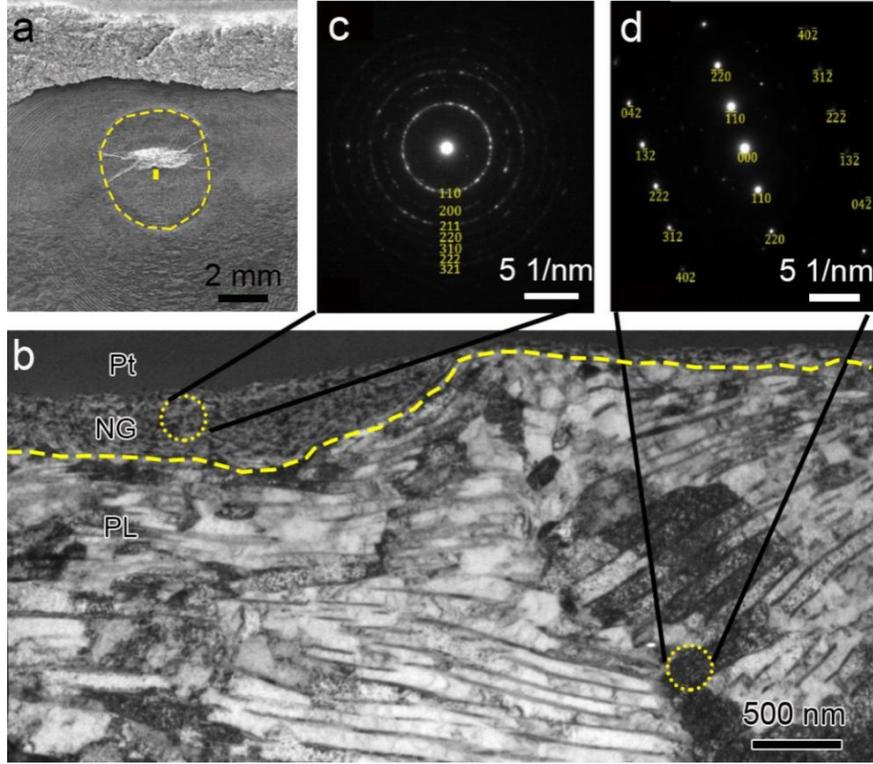
Fig. 8a shows a TEM sample which contains the microstructure in the crack initiation region under rolling contact loading. The sample prepared with the FIB technique was observed by TEM, as shown in Fig. 8b. Three layers are delineated in the sample, i.e., a protective Pt coating layer (Pt), a 50-500 nm nanograin layer (NG), and a pearlite layer (PL). Pt plays the role of protection; NG is a 50-500 nm thick nanograins; PL is the origin microstructure of pearlite. SAED was conducted on the NG and PL layers, as shown in Fig. 8c and d, respectively. For the NG layer, the SAED pattern in Fig. 8c is polycrystalline which shows discontinuous diffraction rings, suggesting that several grains existed within the diffraction area. For the PL layer, a pattern of isolated spots is shown in the SAED image (Fig. 8d), which indicates normal diffraction from a single grain. Therefore, we can infer that a layer of nanograins was formed from the pearlite. Away from this narrow layer, the microstructure had the features of pearlite.

Fig. 8. SEM image, BFI and SAED patterns of crack initiation region for the case under rolling contact loading: (a) SEM image with the TEM sample location marked by the rectangle; (b) BFI of the microstructure in the FiE region. (c) SAED pattern under the FiE surface, and (d) SAED pattern away from the FiE surface.

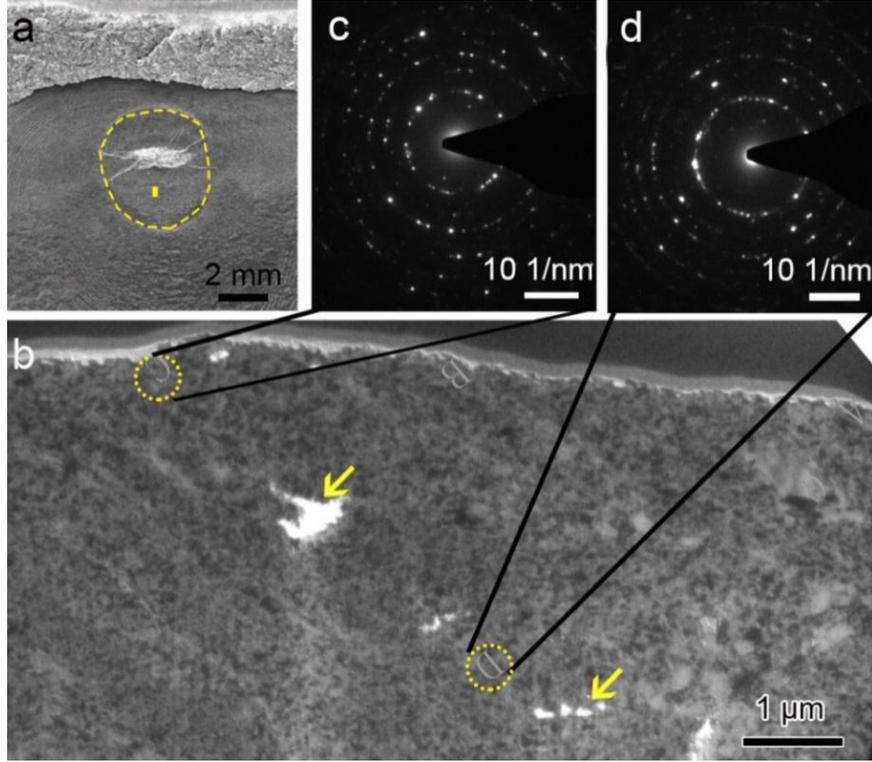
We examined the cross-sectional structures of the samples in the FiEs during VHCF under axial loading (Fig. 9) and rolling contact loading (Fig. 10). Fig. 9a and Fig. 10a show the TEM sample position obtained by the FIB technique, which was far away from the inclusion and located in the middle of the FiE. The BFI results in Fig. 9b present the original pearlite, indicating that grain refinement did not occur in the whole FiE region, and isolated spots from a single grain were present both underneath and far away from the FiE surface (Fig. 9c and d). For the VHCF under axial loading, grain refinement did not occur in the crack initiation and early propagation regions. However, for the VHCF under rolling contact loading, only nanograins were observed, and the original pearlite disappeared completely, as shown in Fig. 10b, which was confirmed by the SAED results (Fig. 10c and d). These results indicated that grain refinement existed both underneath and far away from the FiE surface. For axial loading, no grain refinement occurred in the FiE. Thus, refinement occurred during VHCF under rolling contact loading. It is worth noting that microcracks were observed in the nanograins (marked by arrows in Fig. 10b).

Fig. 10. BFI and associated SAED patterns of the FiE for the case under rolling contact loading: (a) TEM sample location marked by the yellow rectangle, (b) BFI of the microstructure underneath the FiE surface, (c) SAED pattern underneath the FiE surface, and (d) SAED pattern away from the FiE surface.

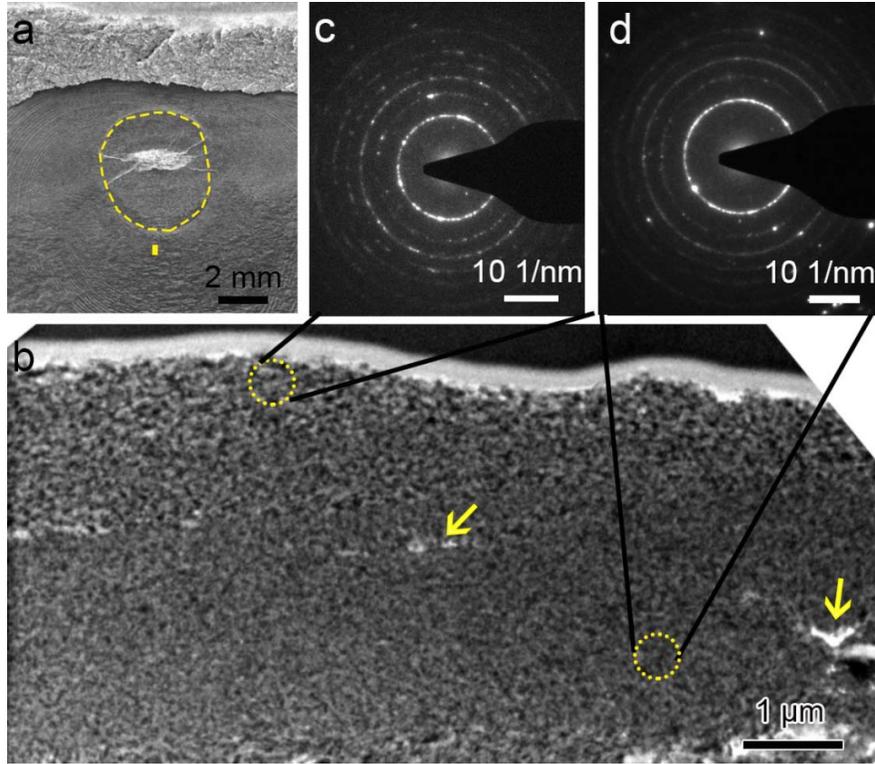
The microstructure of the FiE for the case of VHCF under rolling contact loading was characterized by TEM, as shown in Fig. 11. The TEM sample was prepared by the FIB technique, and the sample location is presented in Fig. 11a. The BFI results in Fig. 11b show nanograins in the whole sample, and microdamage marked by arrows also formed. The SAED results in Fig. 11c and d show discontinuous diffraction circles that are clearer than those in Fig. 7 and 9. It is interesting that nanograins formed even away from the FiE.

Fig. 11. SEM and TEM images of the extracted cross-section TEM samples out of the FiE region for the specimen that failed under rolling contact loading. (a) SEM image of the extracted cross-section locations by FIB, (b) BFI results of the extracted cross-section samples, and (c) and (d) SAED patterns underneath and away from the fracture surface, respectively.

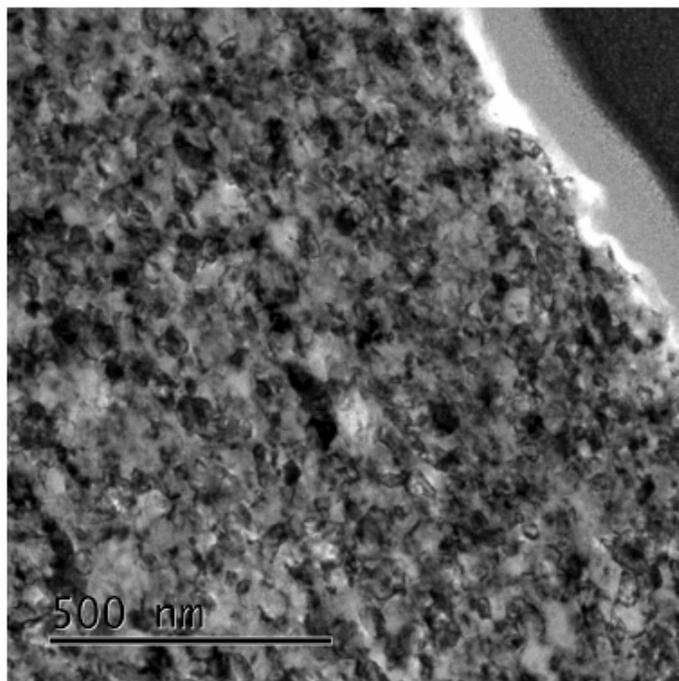
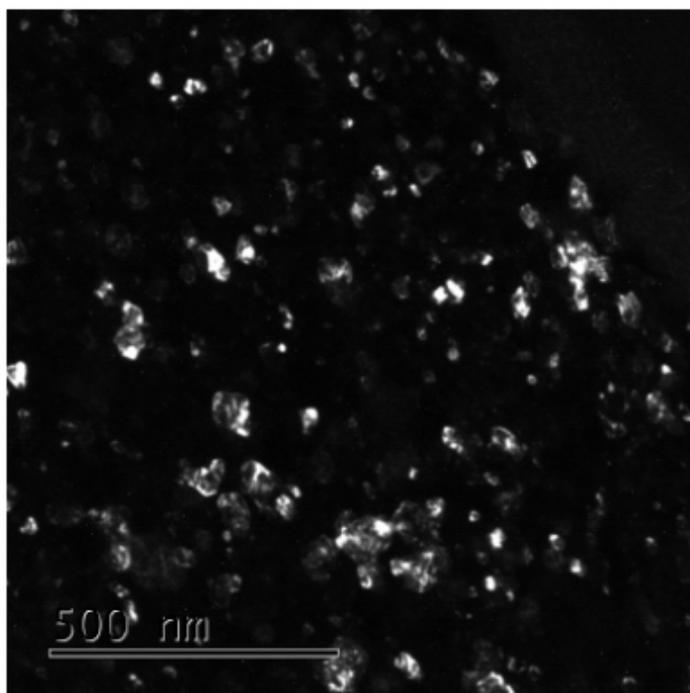
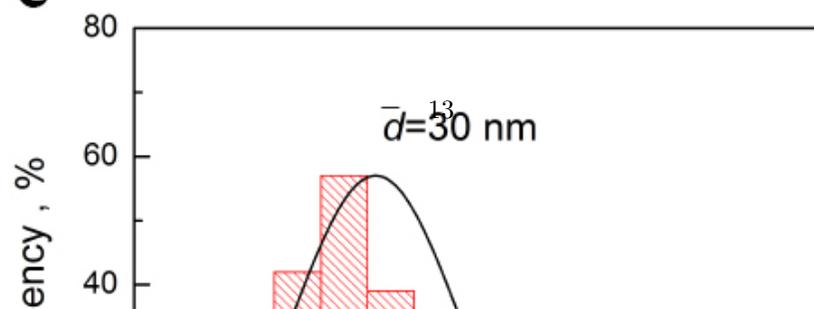
Fig. 12a and b present a high-magnification BFI and corresponding dark-field image of the NG layer, showing nanograins in the NG layer with a distinct morphology in the crack initiation region under rolling contact loading. Subsequently, the grain sizes in the NG layer were measured from the BFIs. The result was based on the measurements of 517 grains. Fig. 12c shows the distribution of the nanograin sizes, indicating that the nanograin sizes range from 18 to 86 nm with an average value of 30 nm. The diameter of the original pearlite is 8 μm on average, and the average width of the lamellar ferrite in the pearlite is approximately 145 nm. The microstructure evolution in this area is a grain refinement process with a scale from micrometers to nanometers.

Fig. 12. High magnification images of the NG layer and the distribution of grain sizes in the NG layer. (a) BFI of the NG layer, (b) dark-field image of the NG layer, and (c) size distribution of the nanograins.
