Cutaneous abscess related to peritoneal catheter tunnel infection

Yoshihiro Nakamura^{1,*}, Tsuyoshi Watanabe¹, Naoho Takizawa¹, and Yoshiro Fujita¹

¹Chubu Rosai Hospital

September 25, 2021

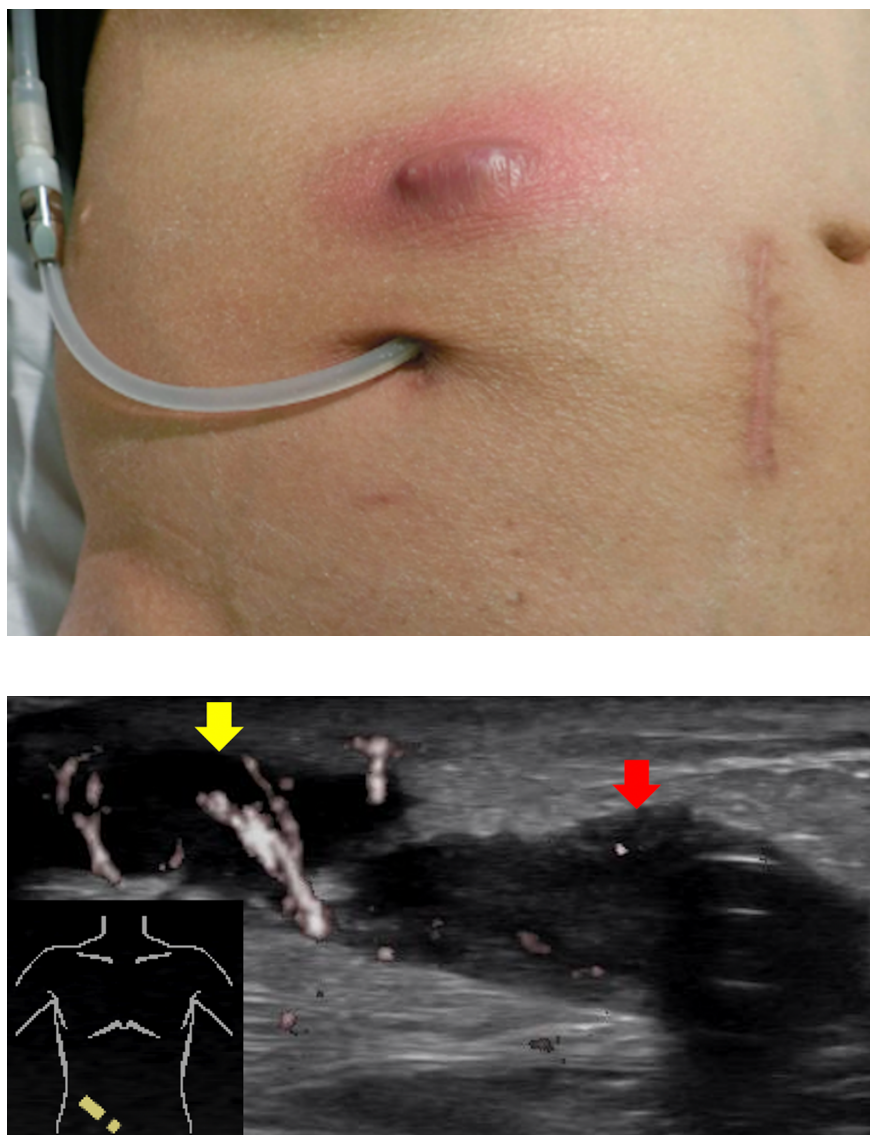
Figure 1. A 1×2 cm area of cutaneous nodule surrounded by skin redness. Figure 2. Ultrasound image shows the PD catheter and hypoechoic zone around the catheter (indicated by the red arrow). Spread of the peri-catheter collection toward the abscess. The abscess, shown with intense power Doppler signal, exists just under the skin (indicated by the yellow arrow).
