Occult Arterial Bleeding Associated With Cardiac Device Implantation

Short Title: Arterial injury after pacemaker implantation

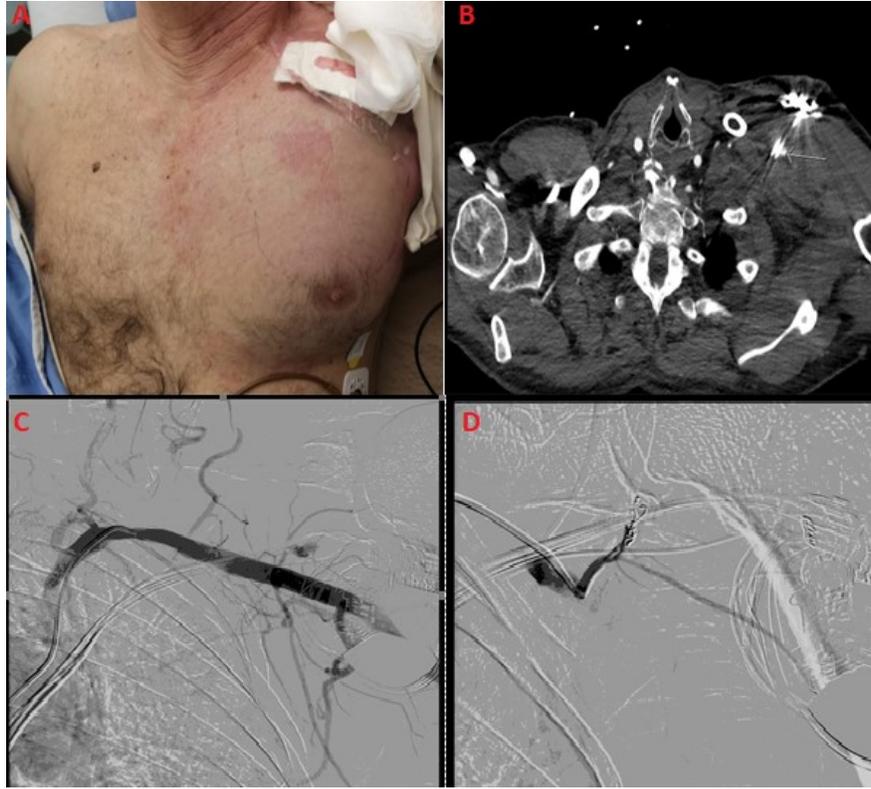
Figure 1 First Patient

1 A. Hematoma of the patient after pacemaker implantation, **1 B** Hematoma under pectoral muscle and extravasation on computerized tomography, **1 C.** Extravasation of subclavian artery branch on the catheter laboratory, **1 D.** After coil implantation to the perforated artery

A computed tomography angiogram scan of the thorax was performed. A large hematoma in the region of the pectoralis major muscle and extending into the left axilla region was noted with contrast extravasation into the hematoma suggesting active arterial bleeding from the thoracoacromial branch of the left axillary artery (Figure 1B). After discussion with vascular surgery and interventional radiology, coil embolization was performed (Figure 1 C, D). The hematoma no longer expanded, and slowly resolved over the ensuing week.

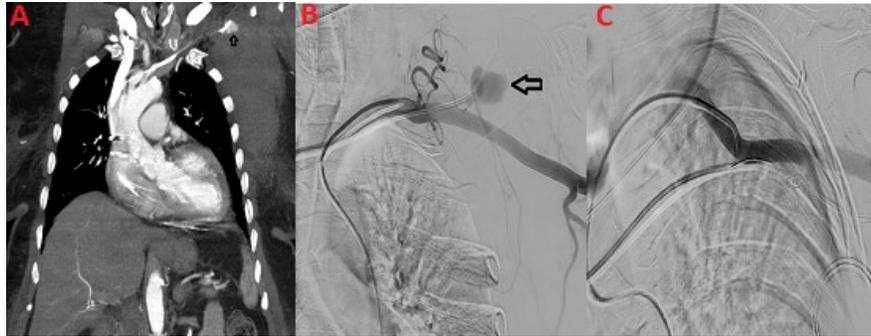
Figure 2 Second Patient

2 A. Hematoma and Extravasation on computerized tomography, **2 B.** Extravasation of subclavian artery branch on the catheter laboratory, **2 C.** After coil implantation to the perforated artery

An 84-year-old woman underwent implantation of a single lead atrioventricular (VDD) pacemaker via an axillary approach. Pectoral swelling with an associated reduction in her hemoglobin from 12.2 g/dl to 5.0 g/dl was noted. After 2 units of packed red blood cells were transfused the patient was urgently taken to the operating room for exploration of her device pocket. A hematoma was not identified during this procedure but minor oozing from the initial puncture site was noted and subsequently cauterized. She continued to have declining hemoglobin, ongoing expansion of her device pocket and experienced an acute kidney injury with creatinine increased to 202 umol/L. CT angiography was performed which identified a chest wall hematoma with active bleeding from a ruptured pseudoaneurysm of the left superior thoracic artery at the site of the pacemaker lead insertion (Figure 2A). The patient underwent emergent coil embolization of the pseudoaneurysm (Figure 2B, C). Antiplatelet therapy was reinitiated and the patient remained stable for the duration of their hospitalization.
