Accidentally extruded calcium hydroxide into a cystic lesion associated with an adjusted tooth. A case report.

Emmanuel Mazinis¹, Nikolaos Tsanidis², and Vasilios Thomaidis³

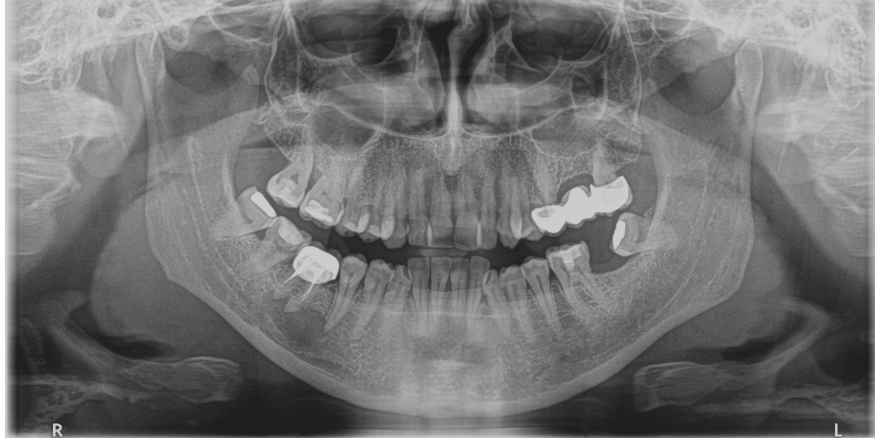
A healthy 46-year-old male presented with pain on percussion in the region of the right lower second premolar (#45). The patient had undergone a panoramic radiograph two years ago, which revealed an incomplete root canal treatment of tooth #46 and a large cystic lesion extending into the surrounding tissues, **including the apex of the second premolar** (Figure 1).

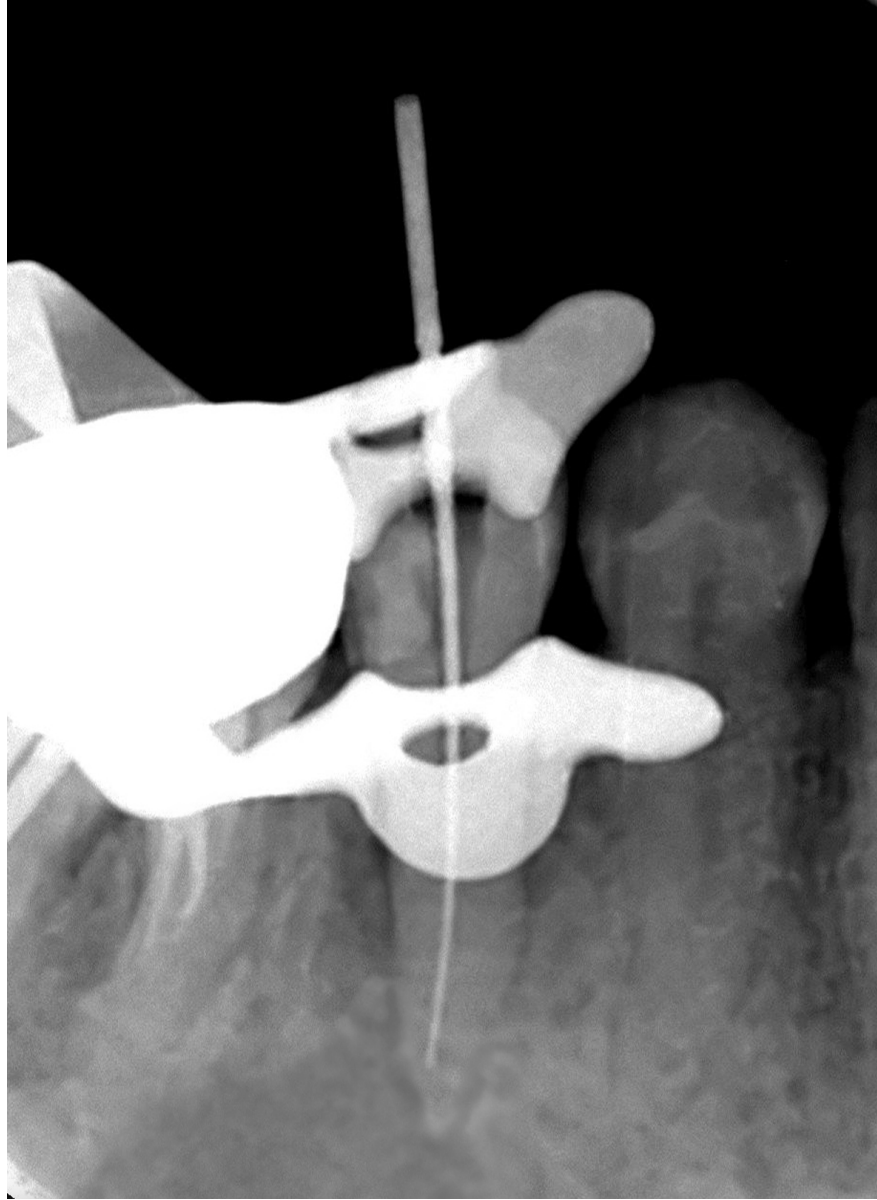
On clinical examination, the second premolar (#45) exhibited significant sensitivity to percussion, with no clinical evidence of carious lesions or history of trauma. The tooth was negative to pulp sensitivity tests. Once the pulp chamber was located, an orifice shaper was used to widen the access cavity and canal patency was confirmed using a #10 K-file. Root length was calculated using an apex locator and root length

determination radiograph (Figure 2). Motor-driven instruments with a taper of 0.4 in sizes 15 to 45 were used for canal instrumentation.

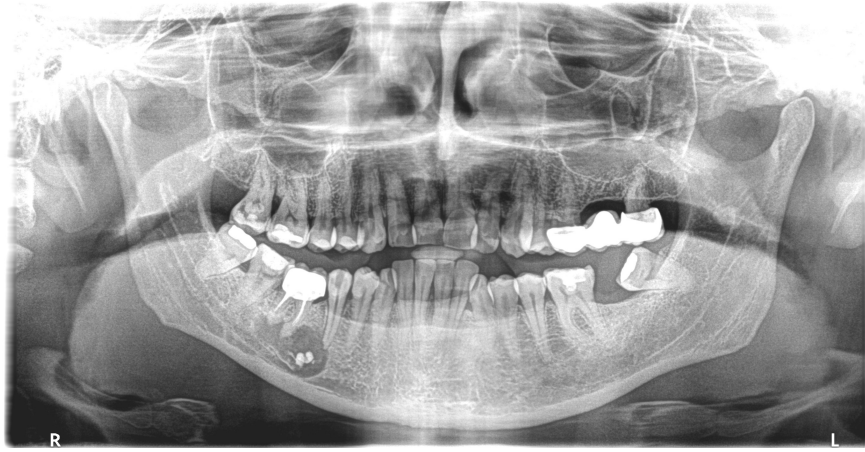
The second panoramic radiograph (Figure 3) revealed extensive extrusion of calcium hydroxide into the cystic lesion in close proximity to the inferior alveolar nerve and mental foramen. Given these findings, a CBCT scan was requested to determine the extent of material extrusion and its relationship to anatomical landmarks. The CBCT provided a detailed view of the cystic lesion and calcium hydroxide extrusion. The scan showed three small radiopaque calcium hydroxide deposits within the cystic lesion. In addition, a radiopaque outline of calcium hydroxide was observed at the periphery of the lesion, extending to its internal margins (Figures 4, 5). The distribution of calcium hydroxide at the margins of the lesion was not visible on the panoramic radiograph. The cyst extended into the jaw bone in proximity with metal foramen without evidence of inferior alveolar nerve. Furthermore, resorption of the apical area of the second premolar was also evident, suggesting that a resorptive process caused its necrosis and loss of apical restriction was the reason of calcium hydroxide extrusion (Figure 4, arrow).

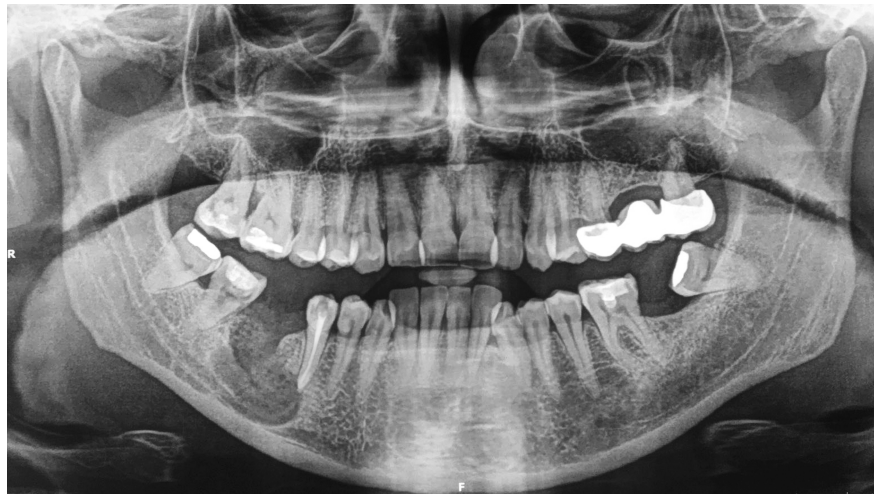
During surgery, tooth #46 was extracted, and the cystic lesion was surgically accessed with particular care to avoid injury to the inferior alveolar and mental nerves (Figure 7). The cystic remnants were preserved and sent for histopathological examination. Calcium hydroxide remnants were located and removed as small masses of coagulated brittle material located within the lesion (Figure 7, arrows). A panoramic radiograph taken two days later confirmed the complete removal of all radiopaque materials (Figure 8).

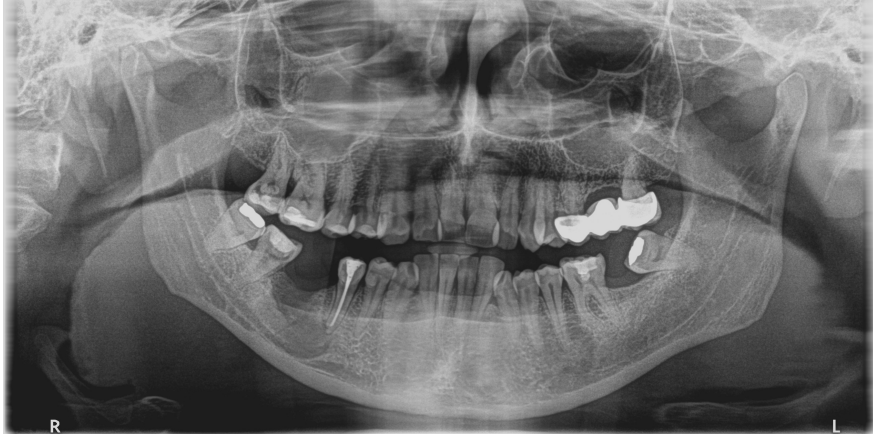
At the three-month follow-up, the patient remained asymptomatic, with evidence of healing of the lesion by formation of osseous tissue both around premolar and surgical area (Figure 9).
