# Measuring and analyzing defects of Additive Manufactured Ti-6Al-4V Specimens through Image Segmentation

The use of additive manufacturing has increased significantly in recent years, particularly in the aerospace industry. However, AM materials often exhibit defects that adversely impact fatigue performance. This study examines the geometric and morphological features of critical defects observed in Ti-6Al-4V specimens.

A framework for automatic fatigue failure analysis through computer vision is proposed. An AI-based tool was trained to identify critical defects, measure their proximity to the surface, and quantify 14 geometric and morphological features. The findings indicate that surface proximity is the most influential factor in fatigue life classification, with defects near the surface exerting a negative impact on performance. No clear trend was observed in defect morphology beyond a certain surface distance. For lack-of-fusion defects classified as critical, the  $X$ -parameter model was applied and a correlation of  $R^2 = 0.91$  with the measured CTF was obtained.

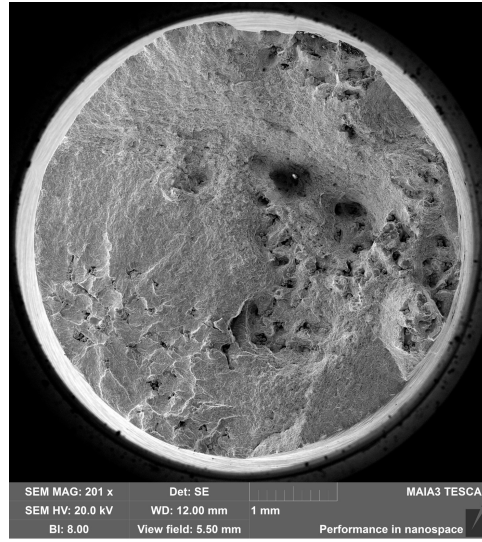
Figure 7: An example of a SEM image of one of the specimens from batch P3 which was dismissed from the analyses of this study due to high porosity which resulted in relatively low fatigue life.
